Cloudburst, Himalayan Tsunami in Uttarakhand

Abstract: *In this article, we discuss the cloudburst triggered natural hazards mainly flash floods, rain and landslides in the Uttarakhand Himalaya. It further describes mechanism, implications of natural hazard, illustrates the preventive and mitigation measures. We discuss in this study through collection of old data, case study of cloudburst hit areas, and rapid field visit of the different affected regions. Cloudburst and rain is one of the biggest natural disasters in Uttarakhand state and this brings flash floods, landslides and massive destruction of property and lives almost every year in the state. The present paper discusses about flood and landslides which occurred due to cloud burst and heavy downpour in between 14 to 17 June, 2013 in the state. Uttarakhand is very susceptible to landslides and almost three fourth of the total geographical area of the state comes under sever to high landslide risk zone. The catastrophe started with cloud burst near Rambara in Rudraprayag district and due to torrential and continuous rainfall, almost all the major rivers and especially the Mandakini and the Alaknanda swelled up. Overflowing

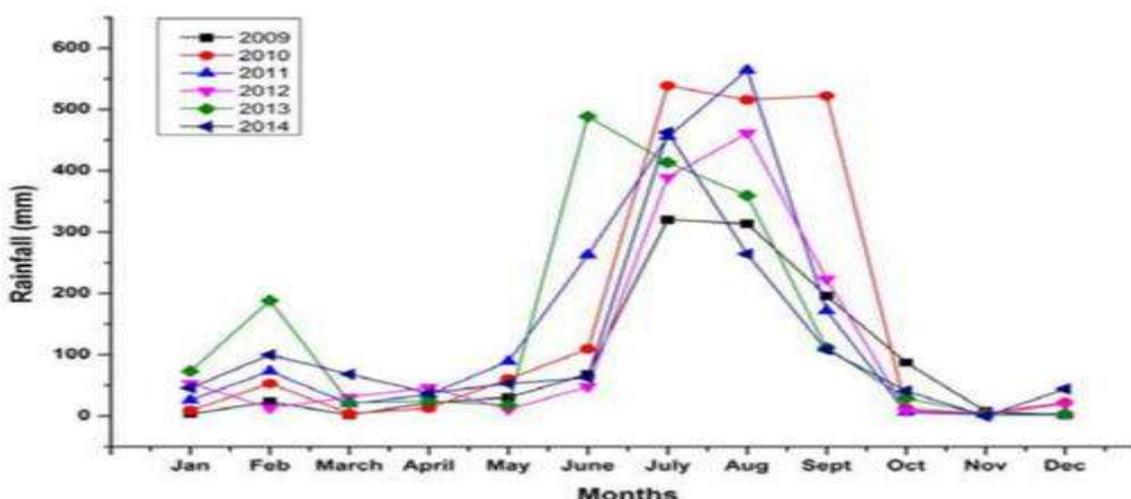
Average monthly rainfall (mm) in Uttarakhand (2009-2014)

We analyzed average monthly rainfall data (2009-2014) of Uttarakhand state and observed that rainfall occurred largely during four months of summer between June and October with high variability. This is the season when cloudburst is occurred. A decrease in rainfall was also observed during the reported period (Fig. 1) however, intensity of rainfall has increased within a short period of time, which has further accentuated magnitude of cloudburst-triggered natural hazards.

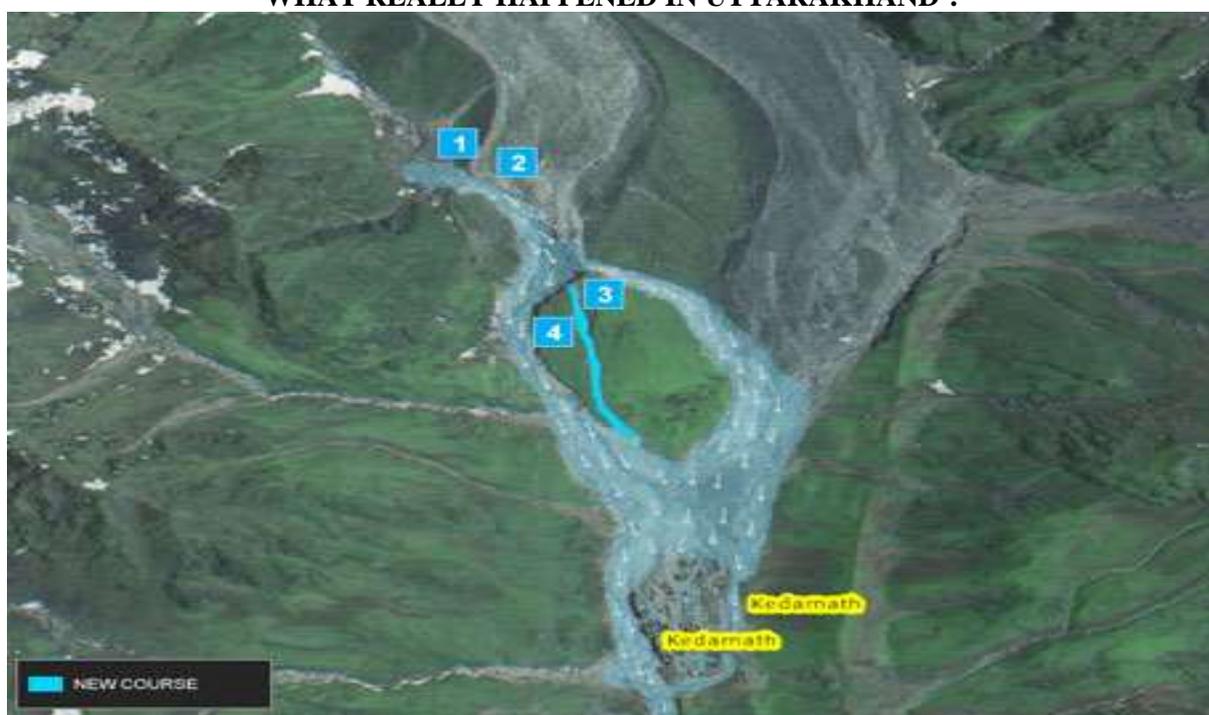
WHAT REALLY HAPPENED IN UTTARAKHAND ?

The extreme rains of June 16 this year lead to a disaster of unprecedented proportions in the Himalayan state of Uttarakhand. Many theories and explanations for the disaster have surfaced in the aftermath of the floods in the state. Now clearer satellite images of the upstream and downstream areas of the Kedar valley that have emerged are enabling a clearer understanding of the scientific and environmental reasons for the tragedy in the state.

It is believed that a massive landslide occurred upstream in the north-east region of the Kedar valley. Heavy rainfall occurred at the same time formed a small lake in the north-west of the valley. The debris from the landslide and water from the lake travelled down the slope, channelled into the glacier, and came down to Kedarnath town. The Indian Space Research Organisation (ISRO) is yet to come up with a detailed analysis but agrees with this possibility.

The difference in height between the crown of the landslide and the channel below was about 500 metres, and the length was about 1,200 metres. Petley puts the scar width at about 75 metres, considered a large landslide. As the

downside of the landslide was active and prone to erosions, it created a further accumulation of debris downstream. The amount and flow of debris was so high, that the boulders did not stop at Kedarnath and were carried to Rambara village and beyond.

Heavy rainfall that occurred in the area at the same time formed a small lake in the north-west of the valley. Under normal circumstances, the water would have flowed away. But a block formed by debris led to the accumulation of water. When extreme pressure caused a breach in the boundary of the lake, a large amount of water gushed out, forcing another rock to flow away. This created a new stream, in addition to the two streams that existed already. The amount of water, moraines and debris was high enough to increase the level of the biggest stream in the west, create a new stream in between, and increase water level substantially in the eastern stream.

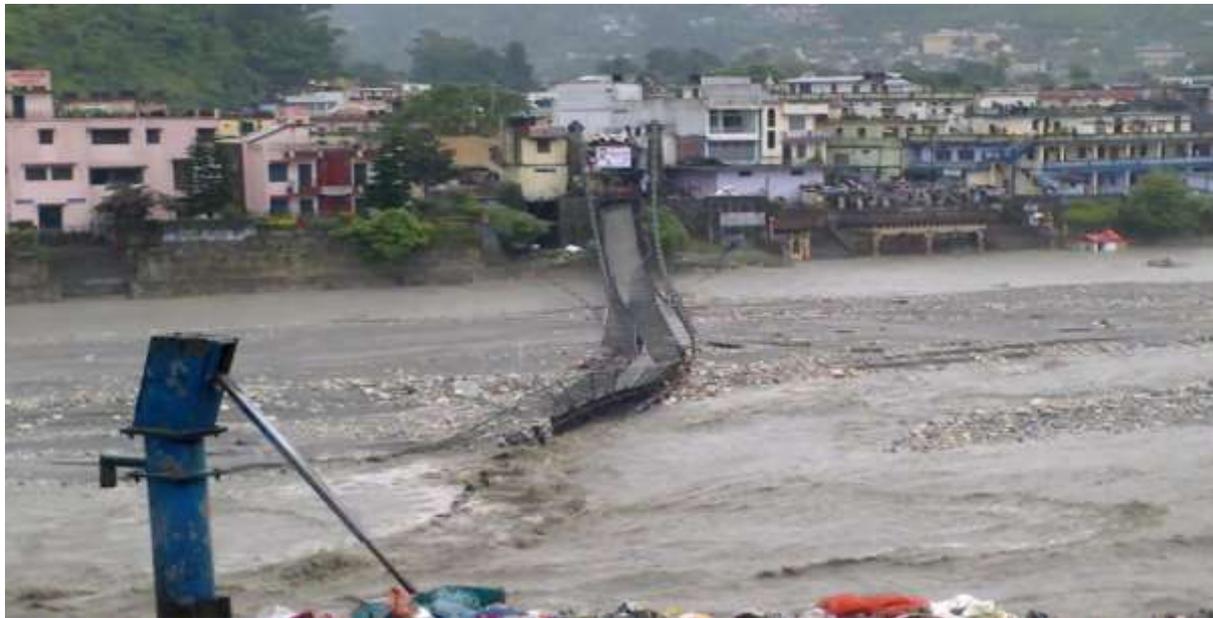
DAMAGE ASSESSMENT AS OF 8TH AUGUST 2012

The major damage has occurred around Uttarkashi township, which is 210 Km. from state capital Dehradun in Uttarakhand. The national highways from Uttarkashi to Gangotri are completely blocked. The bridge connecting Uttarkashi town and Bhatwari block at Gangori village is collapsed and almost 80 villages are totally cut-off. There is no way to communicate with the people in those areas.
